Test report No:  
NIE: 65849RTT.001

## Field Test report

### E2E performance testing of parking sensors system

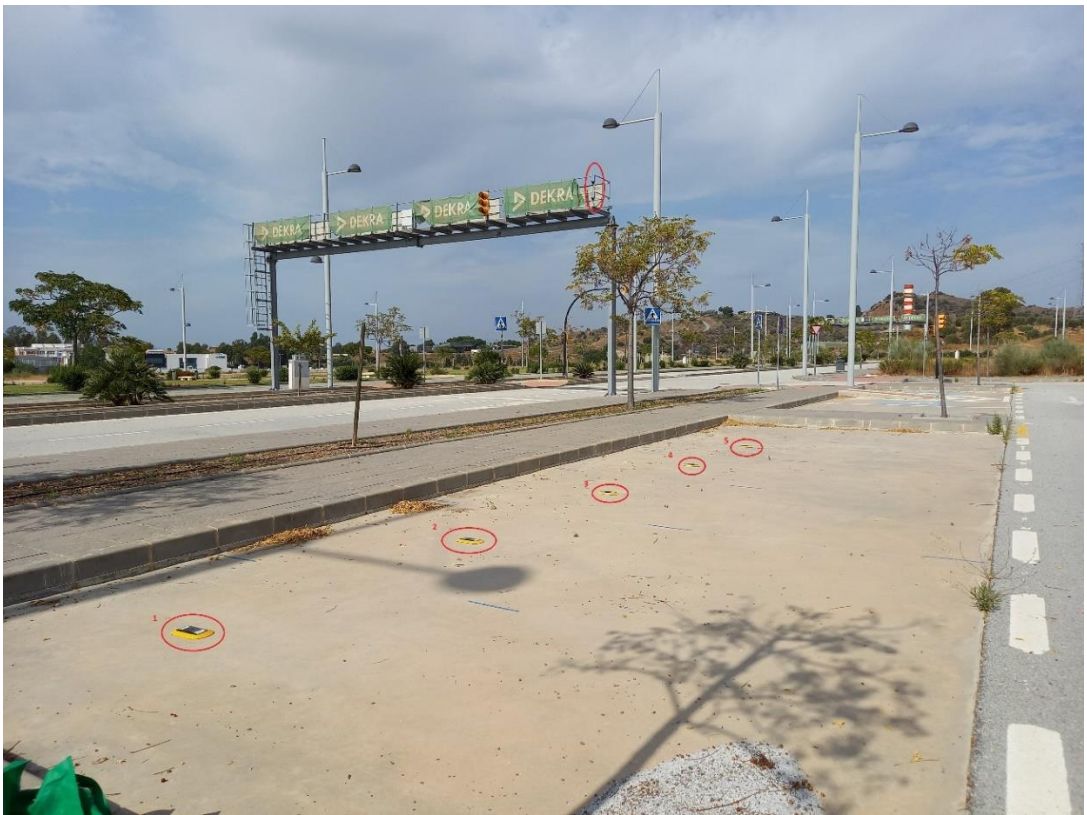
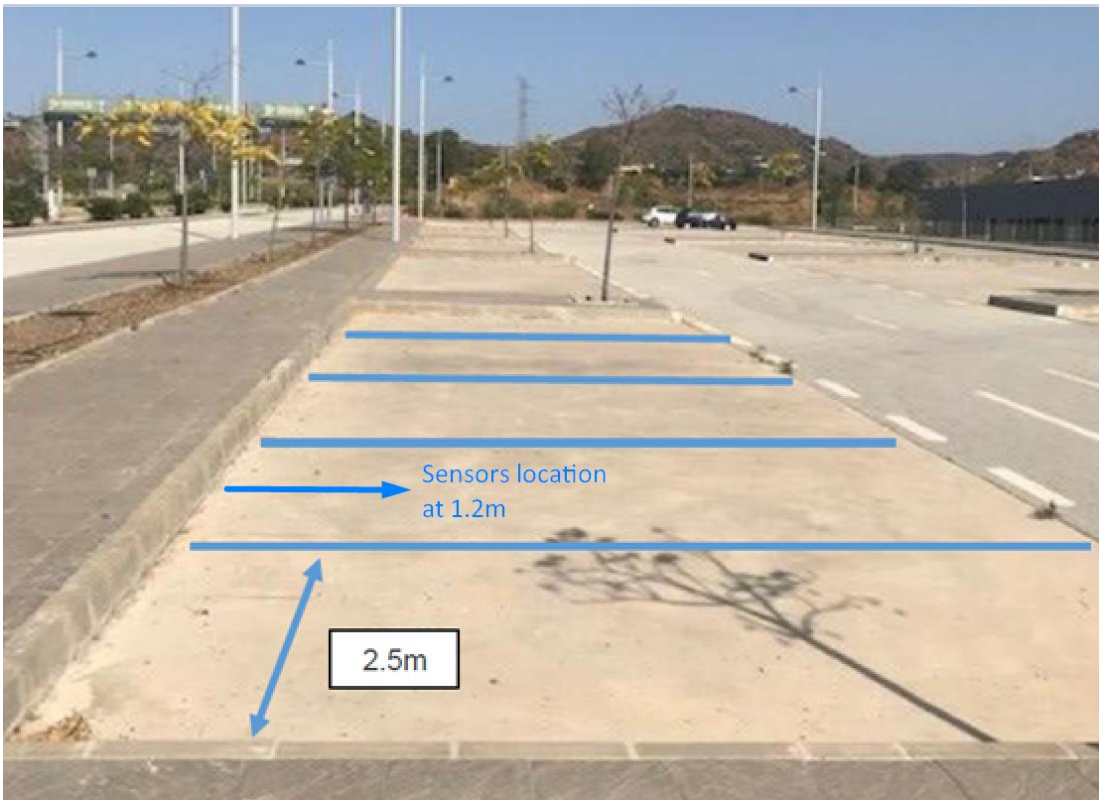
**Sensors and Gateways locations:**

- The placement of both gateways together and connected permanently with a minimum high of 4 meters and no further than 30 meters for an optimal functioning
- The 5 sensors placed in row, one per parking space
- The E2E system composed by 5 sensors and 2 gateways
- Each parking space with a width of 2.5 meters
- The placement of the sensors should be 1.2 meters on the opposite side of the vehicle entrance
- Power lines should not be present under the parking spaces
- Test execution limited to one working day.

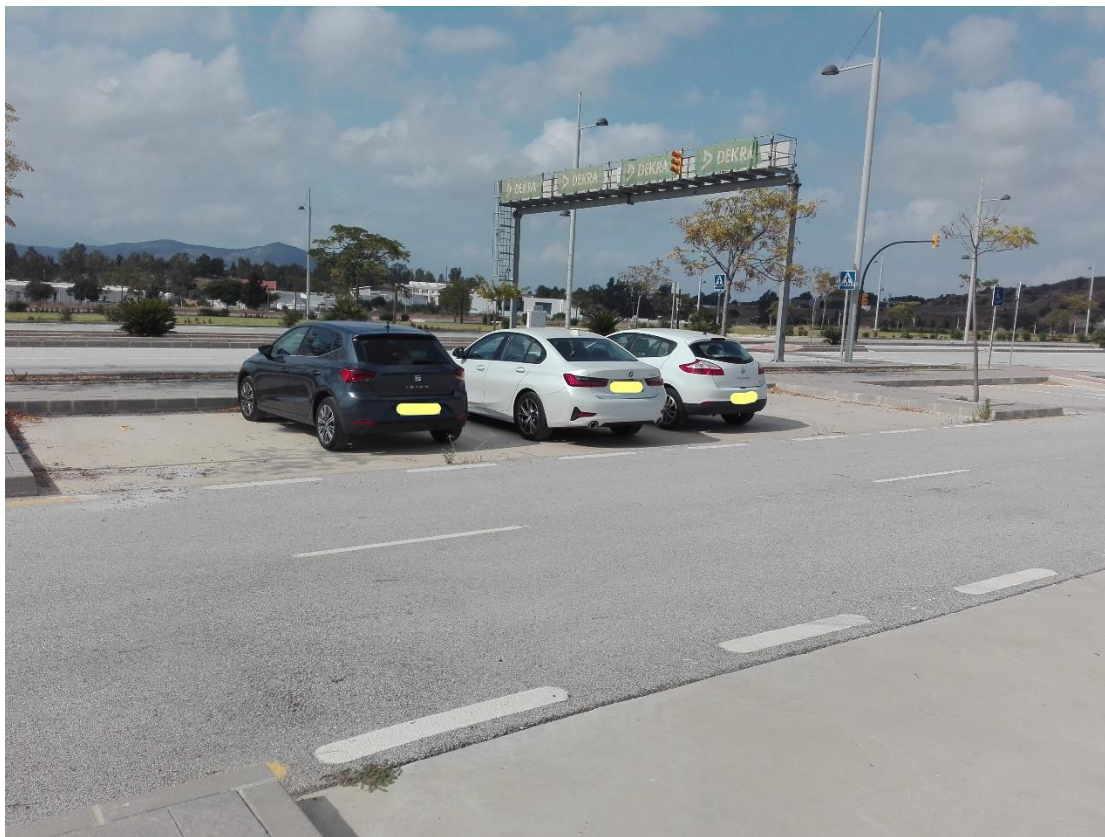
**Vehicles employed for the testing:**

- Vehicle A: BMW Serie 3 320d Automatic
- Vehicle B: Seat Ibiza 1.0 MPI 75 CV of the year 2017
- Vehicle C: Renault Megan Berlina Life Energy dci 90 of the year 2014

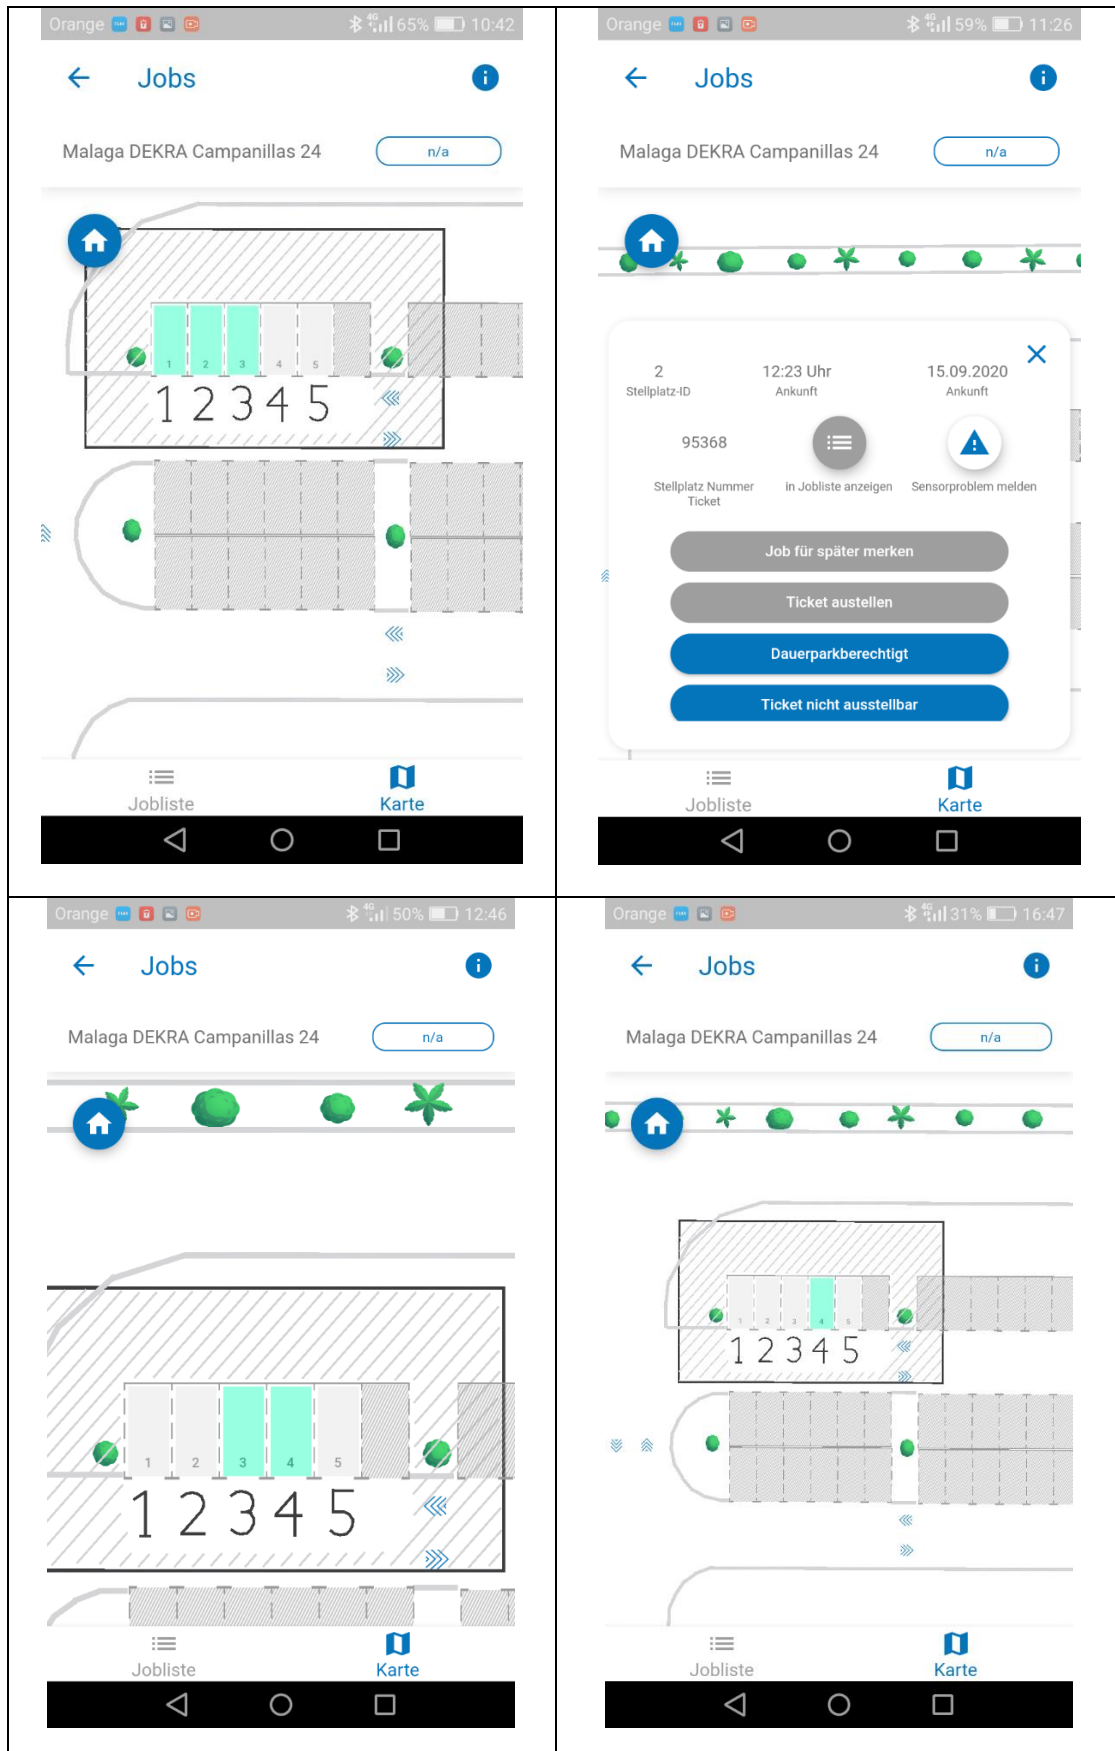
**Some Inspections App occupancy states:**
